EISENHUTH DAM
NDS ID NO. PA-00662
DER ID NO. 54-55

PHASE I INSPECTION REPORT
NATIONAL DAM INSPECTION PROGRAM

EISENHUTH DAM

PHASE I INSPECTION REPORT

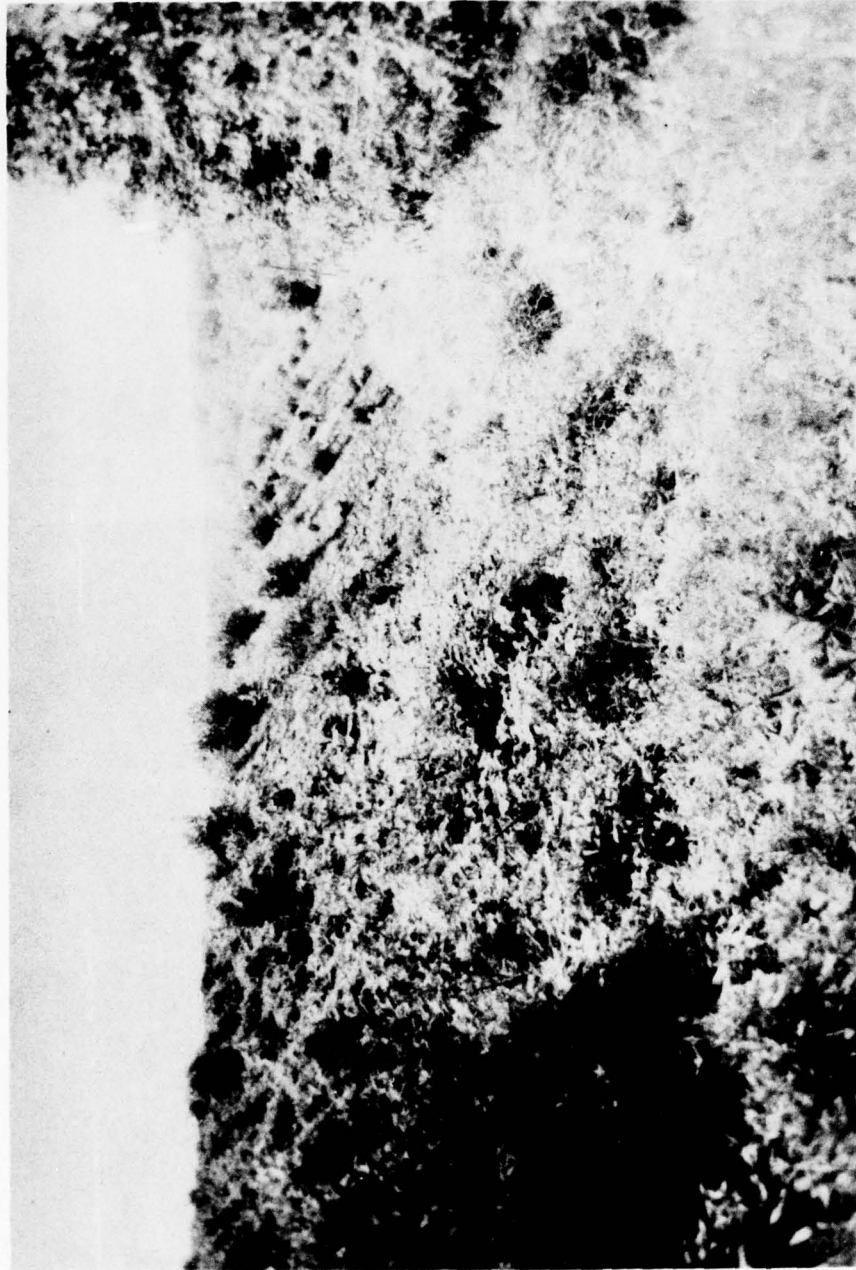
Downstream Slope of Embankment from Right Abutment.

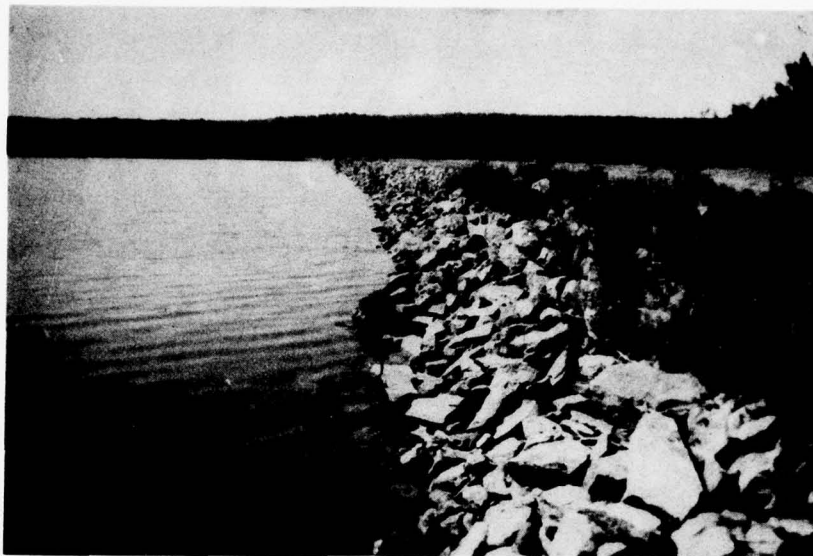
A. Riprap on Upstream Slope of Embankment.

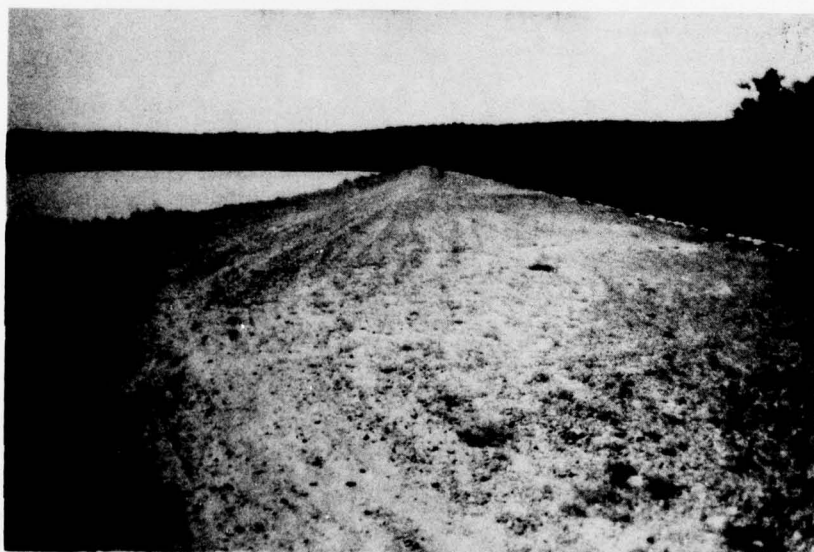
B. Embankment from Right Abutment.

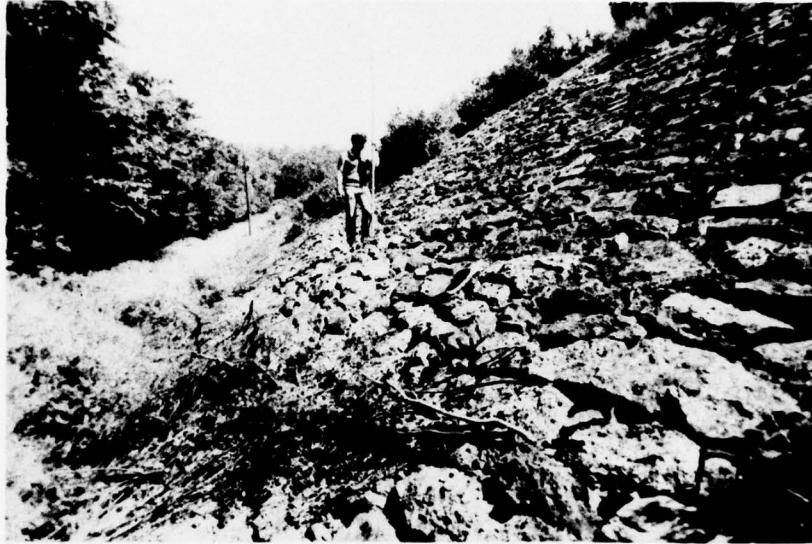
(2) Embankment. Three seepage areas were observed at or near the toe of the embankment. Bulges near the downstream toe were noted on the embankment slope. The detailed description and evaluation of these conditions are in Paragraph 3.1b.(4) and Paragraph 3.2a.(4), respectively.

(4) The combination of steep embankment slopes, particularly the downstream slope, and seepage are such that it is believed that the embankment stability factor of safety is close to unity. A change in conditions from those observed during this inspection could adversely affect the stability of the embankment.

C. Downstream Toe of Embankment and Bulging of Riprap.

- (4) Install two or more inclinometers in the downstream slope of the embankment near the maximum section to monitor any slope movement.
- (5) Clear the area along the downstream toe of the embankment and identify all seepage outlets. Construct a system of channels and weirs so that flow measurements can be made for all seepage points and so that any accumulation of soils that might be coming from the embankment can be recognized. Monitor and record data so that any change in conditions is readily apparent.

- (6) Perform surveys to more accurately determine the existing embankment template.
- (7) Undertake an embankment and foundation exploration program to ascertain the engineering properties of the materials and perform a study to determine the

factor of safety for stability of the embankment. Take any remedial action that might be found necessary to ensure stability of the embankment.

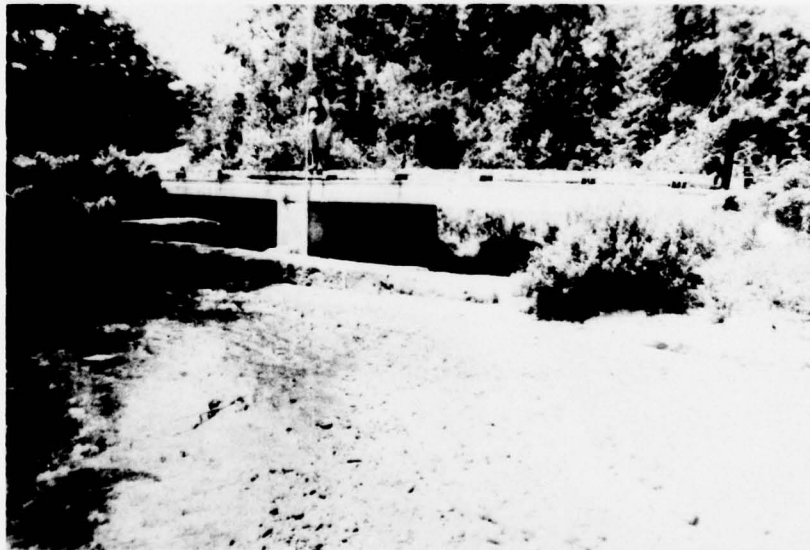
Three tension cracks were observed on the bottom surface of the bridge deck. The cracks extend normal to flow in the channel and were 1/8 inch wide and 1/4 inch deep. No evidence of differential movement at any crack in the bridge deck was observed. The prestressed beams supporting the bridge deck are successively offset about 3/8 inch. The top of the concrete weir that is 44 feet downstream of the bridge was spalled to a depth of 1 inch over a 28-inch by 12-inch area. Coarse aggregate was exposed on the downstream face of the weir directly below the notch in the weir.

D. Left Spillway Approach Channel, Masonry Weir, and Roadway Bridge.

(3) Monitor cracking at the left spillway bridge and at the left spillway right training wall. If changes are noted, take appropriate action.

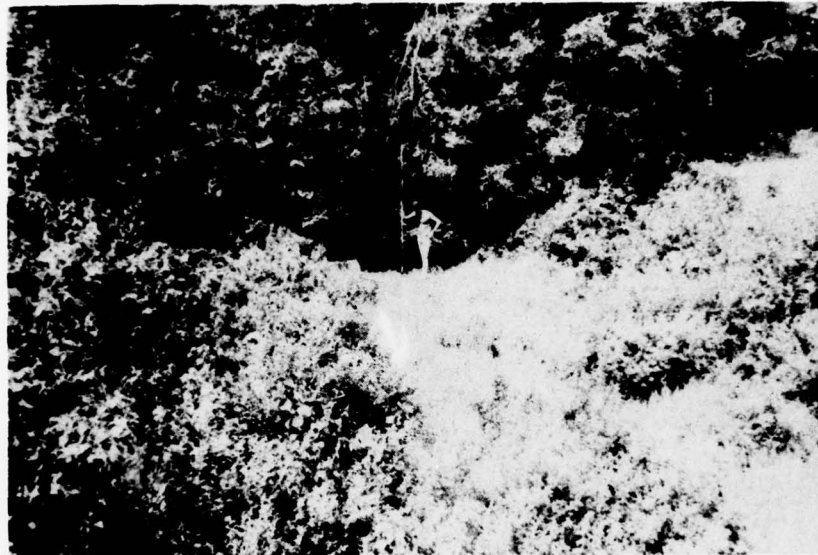
E. Left Spillway Outlet Channel and Concrete Weir — Looking Downstream.

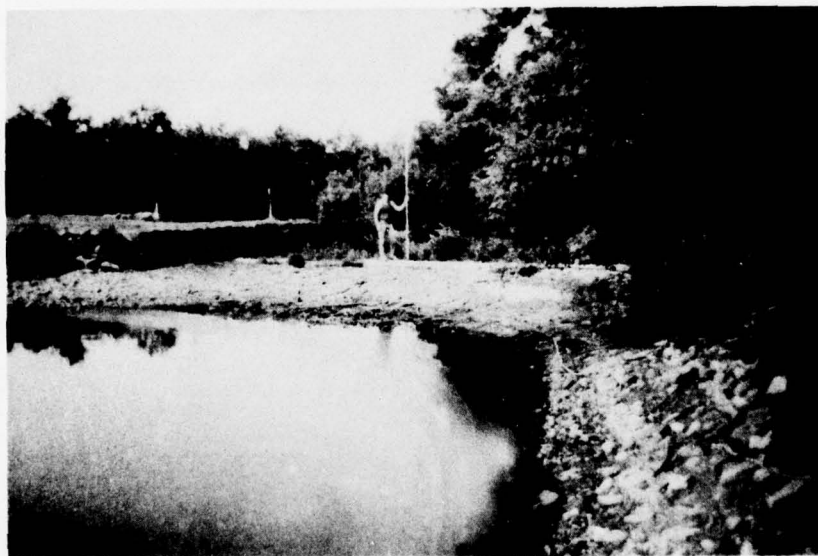
F. Right Spillway Approach Channel and Masonry Spillway Weir.

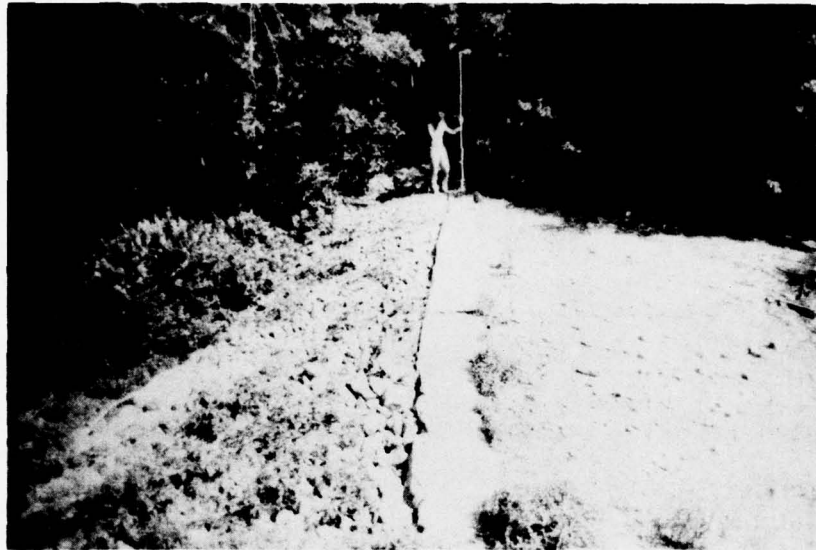
G. Right Spillway Masonry Weir —
Looking Towards Right Abutment.

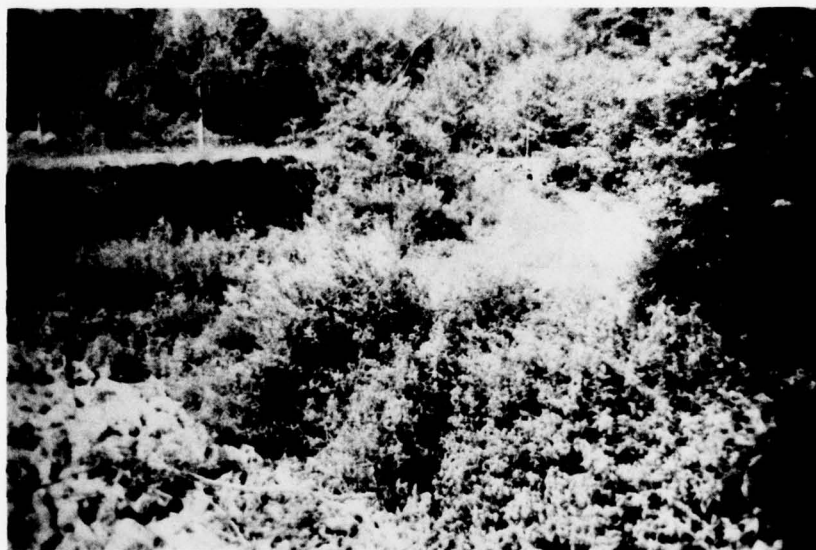
H. Right Spillway Outlet Channel —
Looking Downstream.

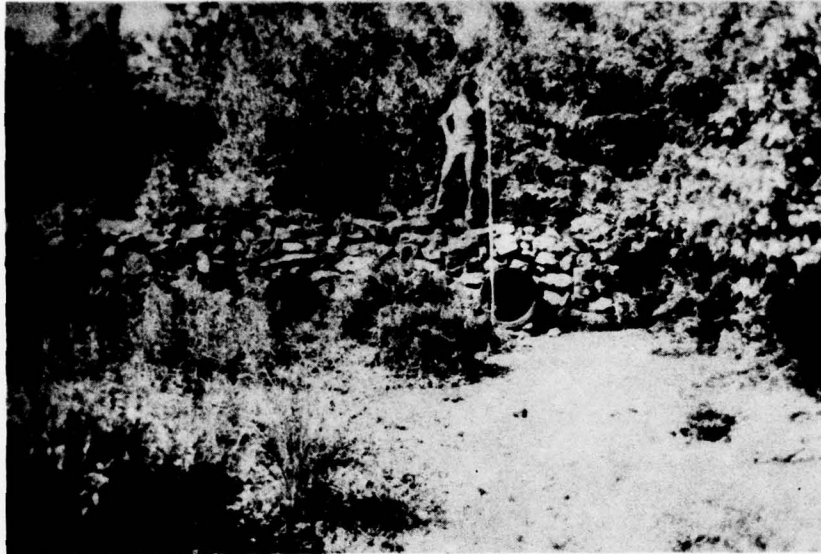
I. Roadway Embankment and Culverts at
Downstream End of Right Spillway Outlet Channel.

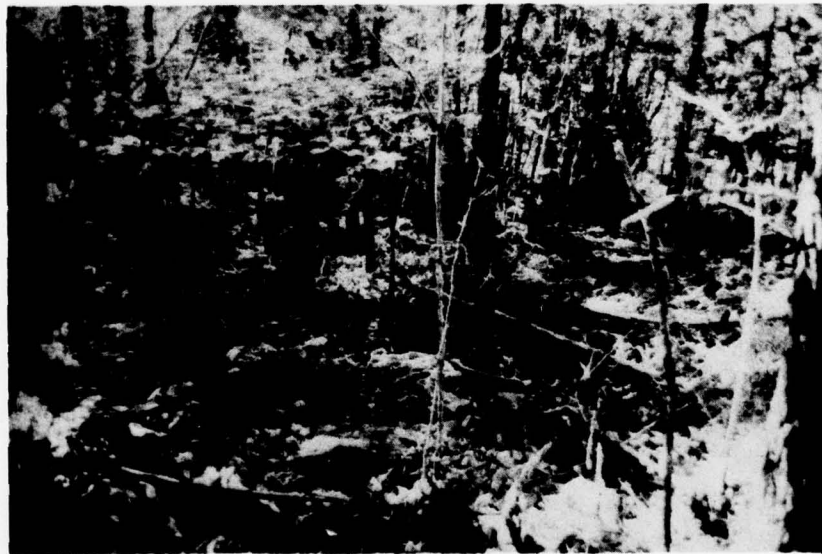
J. Right Spillway Outlet Channel (left) and
Relief Channel (right) — Looking Downstream.

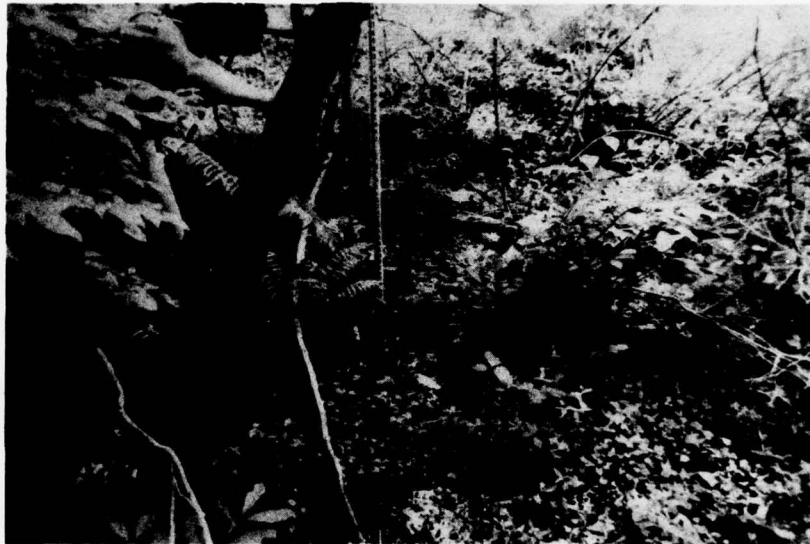
K. Wet Area Downstream of Toe.

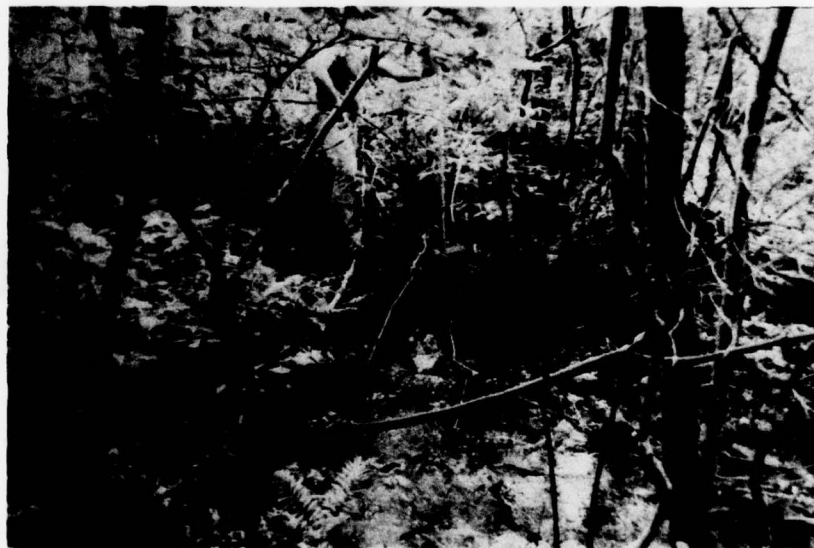
L. Drainage Ditch Downstream of Toe.
